Understanding the Causes of Stainless-Steel Corrosion in Retorts and Practical Steps to Prevent Corrosion – a Primer

By Jeff Arthur, Technical Sales Director, Allpax, a ProMach product brand

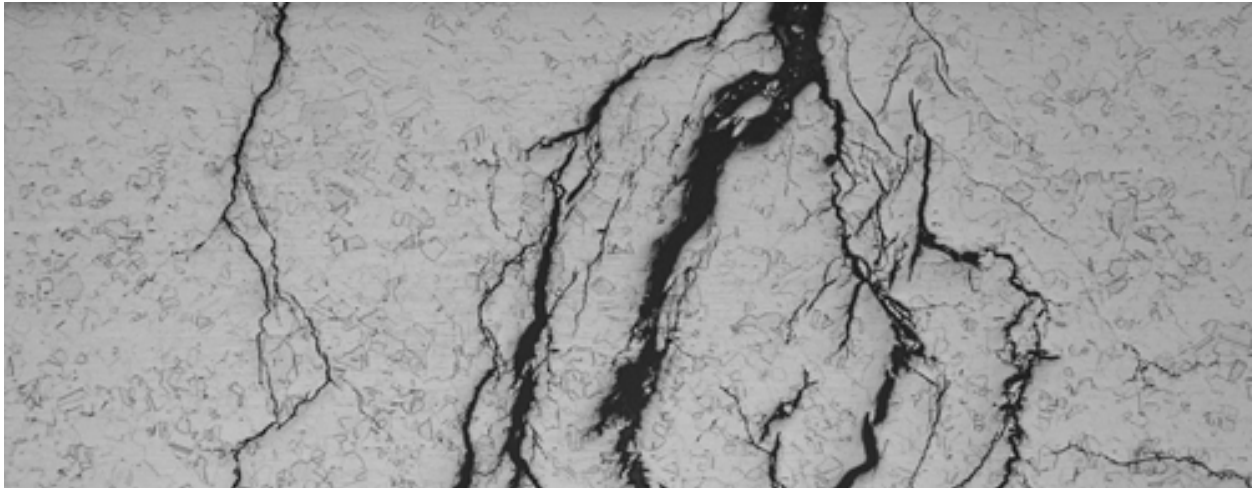
STRESS CORROSION CRACKING - VIEWED UNDER SCANNING ELECTRON MICROSCOPE

There are three different types of corrosion normally found in stainless-steel retorts. The most insidious is stress corrosion cracking (SCC), sometimes called chloride stress corrosion cracking. Once stainless steel begins cracking, the damage is permanent and not repairable. Highly stressed areas of steel inside the retort system are normally affected first. When high levels of chlorides, adequate oxygen, water, and high temperatures combine, the SCC corrosion reaction can start.

SCC infections weaken stainless steel, causing it to become brittle. The fact that metal is continuously expanding and contracting through repetitive heating and cooling cycles

accelerates SCC when the corrosive conditions exist. There is no remediation for SCC affected metal once it has started. Removing a weakened section and welding in a new one is often ineffective as it just adds more heat and stress to the already affected area. The retort becomes unreparable when the problem is in advanced stages.

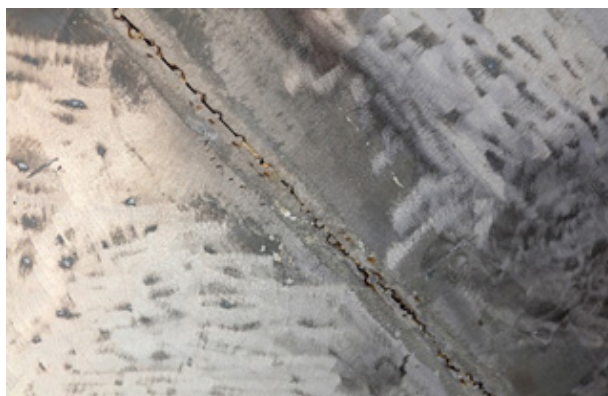
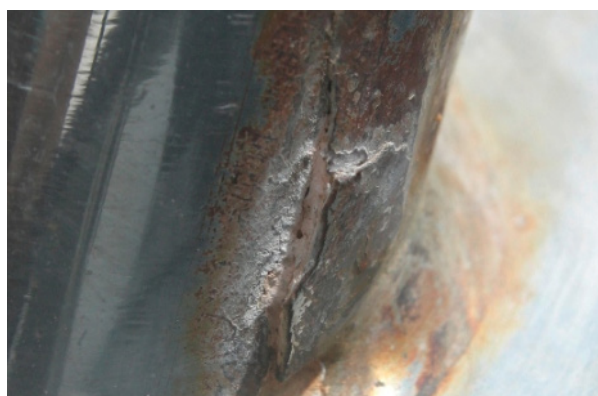
CREVICE CORROSION

The second type of corrosion found in stainless steel retorts, crevice corrosion, is caused by concentrations of chlorides filling small spaces between two parts or voids where water has stagnated. Only one part needs to be stainless steel, the other can be stainless or another material such as a gasket. As the retort cycle temperature and pressure increases, water combined with a concentration of chlorides works its way into small cracks lacking the free flow of oxygen over the area and the corrosion reaction starts. These crevices can be as small as .005 inch (0.127mm) when they start and grow to large pockets that are inches in size, eroding the metal away. As the retort fills and empties cycle after cycle, the concentration of chlorides in the cracks rises and becomes even more corrosive, enlarging or undermining the crevice and weakening the

metal.

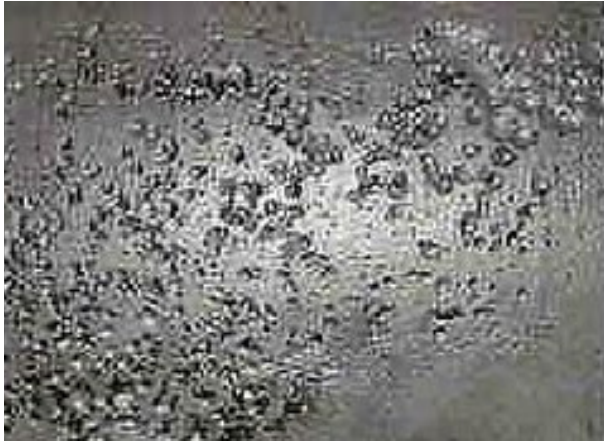
PITTING CORROSION

The third type of stainless-steel corrosion commonly found in stainless retorts is pitting. When pitting corrosion has progressed, it is visible to the naked eye and sometimes is in open areas that are easier to see - but not always. Pitting does not always follow a set of rules on why one area is pitted, and one area is not, on the same steel surface. Small pits in the steel start to develop when the metal surface is exposed to ample amounts of chlorides, hypochlorite (chlorine), or bromide ions in the environment and no metal surface protection is present. Pitting in advanced stages can aggressively erode thick steel, causing leaks.
